Evolution of Grounding Failure-Insulation Failure of 10 kV Cable Joints: Prerequisites of an Explosion in Enclosed Cable Trench

Yifeng Zhao¹, Gang Liu¹, Yaodong Guo¹, Chenglong Huang¹, Zhaoming He¹, and Ran Hu¹

¹South China University of Technology

March 31, 2023

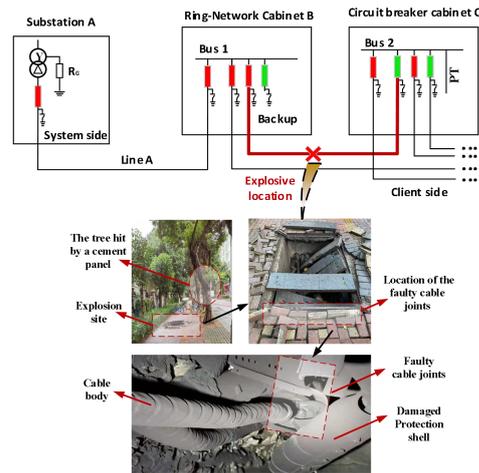
Fig. 1. Electrical connection of the faulty transmission line and the scene of the explosion accident

At the scene in Fig. 1, an explosion accident was witnessed in a cable trench. Three cement panels were lifted due to the explosion, one of which was lifted about 3 meters high, and two of which were lifted about 1 meter high. After the accident, it is found that the whole cable trench was

blackened, and the protection shell of the faulty cable joints has been burned down. According to the field measurement, the cable trench is about 8 meters long, 1.2 meters wide and 0.8 meters deep. Both ends of the cable trench are laid with pipes and the cement panels have no air vents. Therefore, the cable trench becomes an enclosed space. The ambient temperature was 29 °C and the air relative humidity was 92% at that time in the cable trench. Additionally, it was measured that the insulation resistance of three-phase lines was 0 Ω.

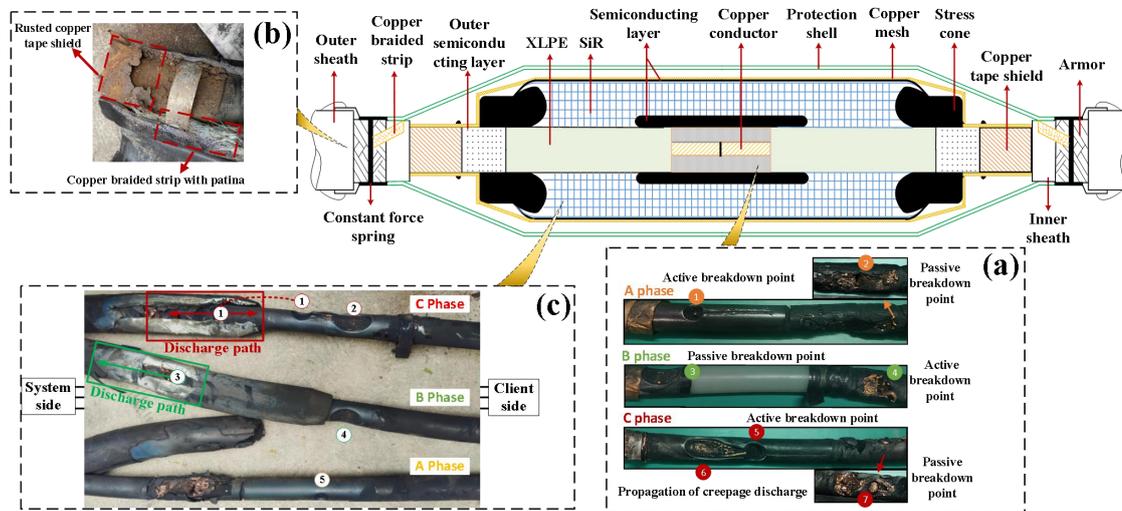
Fig.2. Damage morphology of the faulty cable joint (a) High voltage system, (b) Grounding system, (c) Insulation system

2.2.1 Disassembly analysis of the high voltage system of the faulty cable joints: Each phase cable joint is disassembled to observe the damage of its high-voltage system, and the details are displayed in Fig.2(a). It is observed that crimping pipes of three-phase cable joints are broken down and the copper conductors are exposed. For B phase cable joint, the protuberant morphology of the copper conductor at position ④ indicates this is an active breakdown point. On the contrary, position ② and position ⑦ of the other two-phase joints show these are passive breakdown points. Additionally, there are obvious active breakdown points at position ① and position ⑤ where they locate at the end of the stress cone. Further, the smooth damage morphology at position ⑥ of C phase is probably ascribed to creepage discharge from position ⑤. Subsequently, the breakdown point at position ③ of B phase appears due to the discharge of position ⑥.

2.2.2 Disassembly analysis of the grounding system of the faulty cable joints: Both the copper tape shield of the cable body, and the copper mesh and the copper braided strip of the cable joint ensure the grounding current flows back to the system side when a grounding fault occurs. If the copper mesh and the copper braided strip of the cable joint were broken, the grounding current through the copper tape shield of the cable body would not be conducted to the system side, and the grounding trip protection would fail to be activated. Figure 2(b) shows the damage morphology of the grounding system of the faulty cable joints. It is inspected that the copper tape shields at both ends of the cable joints are seriously rusted due to water erosion. The residual copper braided strips are covered by patina, and the copper meshes are burnt down. Therefore, the grounding system of the faulty three-phase cable joints has completely failed.

2.2.3 Disassembly analysis of the insulation system of the faulty cable joints: Figure 2(c) shows the damage morphology of the insulation system of the faulty cable joints. For C phase cable joint, it is observed that there is an obvious creepage discharge trace at the XLPE-SiR insulation interface. At the end of the stress cone, there is a distinct breakdown point ①. A large current generated at this point flows to the system side through the copper mesh and copper braided strip. The bidirectional discharge path is shown in Fig. 2(c). The current thermal effect leads to the SiR turning into SiO₂ and the partial destruction of the copper mesh. Then, the large current can only flow to the system side through the copper braided strip on the right side of the cable joint. On the one hand, the current carbonizes the outer semiconducting layer of the cable body, leading to the formation of breakdown point ①. On the other hand, the current greatly impacts the copper braided strip and eventually results in its breakage. For B phase cable joint, there is no creepage discharge trace at the XLPE-SiR insulation interface. However, apparent breakdown point ③ is observed. A large current generated

at this point flows to the system side through the copper mesh, which is responsible for the discharge path in Fig. 2(c). Moreover, there is a breakdown point ④ in the cable body.

The damage morphology of A phase cable joint resembles C phase cable joint. There is an obvious creepage discharge trace at the XLPE-SiR insulation interface. In addition, breakdown point ⑤ is found at the end of the stress cone.

Propagation of creepage discharge: in Fig. 2(a), it is found that there is an obvious axial insulation breakdown channel from position ① to position ④. This phenomenon is ascribed to the propagation of the creepage discharge. From the analysis of current distribution, the majority of the current is concentrated in the shadow area of the outer semiconducting layer. Under the electrical and thermal effects, axial insulation breakdown happens first in this area with high current density.

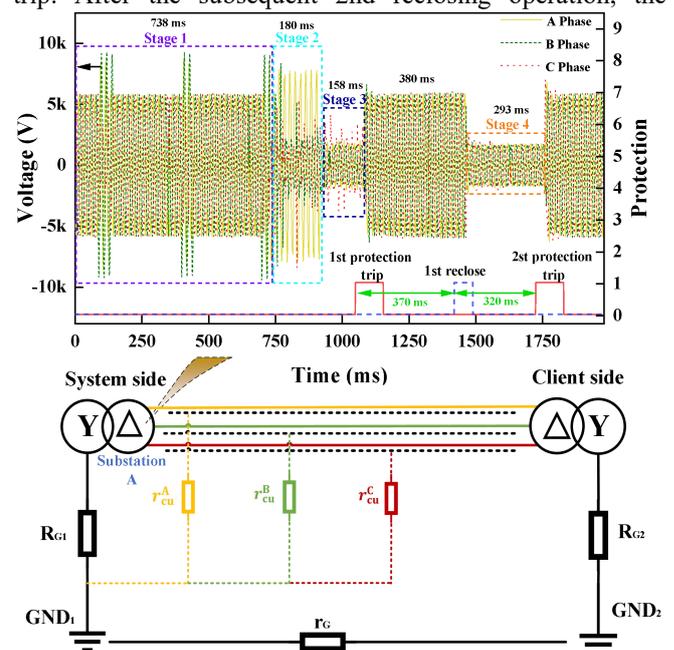
Fig.3 Circuit topology diagram and the recording data before the explosion accident at 9: 27 am

In Fig.3, it is divided into four fault stages according to the voltage change of three phases. At Stage 1, the voltage of A and B phases is lifted due to the descent in the voltage of C phase. At Stage 2, the voltage of B phase is decreased with C phase. At Stage 3, the voltage of the three phases is declined at the same time, lasting for 158 ms. At this stage, 1st zero-sequence protection trip is activated, and the three-phase voltages become normal. After 370 ms, 1st reclosing operation is triggered, and Stage 4 arrived. Similarly, another three-phase voltage drop lasts for 293 ms and results in the operation of 2nd zero-sequence protection trip. After the subsequent 2nd reclosing operation, the

protection identifies that the line returns to normal, and the fault recording data is ceased. From the fault recording data, it is deduced that the fault line has gone through the fault state of high resistance grounding fault, low resistance grounding fault, and grounding failure. In the following research, the fault recording data of each stage will be quantitatively analyzed.

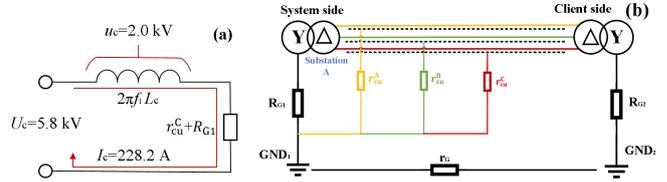
Fig.5 Equivalent electrical models at Stage 4

At this stage, it is concluded that there is a three-phase line-to-ground fault, which has a great impact on the copper mesh and copper braided strip and eventually results in ground failure of the cable joints. The circuit topology diagram of the cable joints at Stage 4 is shown in Fig.5(b).

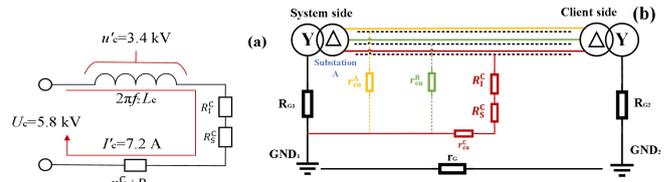
Fig.7 Equivalent electrical models at Stage 1

It is found that the creepage discharge at the XLPE-SiR insulation interface is characterized by high frequency and large current, which is completely distinguished from partial discharge. The circuit topology diagram of the cable joints at Stage 1 is shown in Fig.7(b).

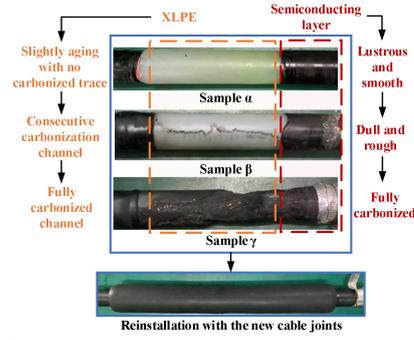
Fig.11 Cable joint samples with different states

α , β , and γ are named according to the states of the XLPE insulation and the semiconducting layer, as shown in Fig. 11. These different states of the cable samples represent the evolution of the long-term creepage discharge at the XLPE-SiR insulation interface of the cable joint. Finally, the cable samples are reinstalled with the new cable joints for the following test.

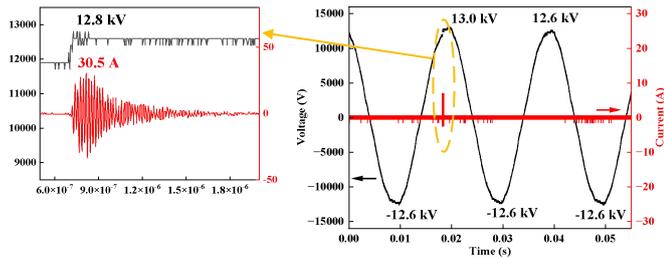
Fig.13 The measured voltage and current waves of Sample α

Fig.13 exhibits the measured voltage and current waves of Sample α . There are obvious pulse currents occasionally under the high voltage of 12.6 kV. Since the SiR insulation of Sample α has no breakdown trace, it is judged that the currents are from the creepage discharge of

the XLPE-SiR insulation interface. It is found that the discharge current duration is 1.2 μ s, and the amplitude is 30.5 A. When the large pulse current occurs, the voltage waveform at the power supply side is slightly distorted, and the voltage rises from 11.9 kV to 12.8 kV. It can be calculated that:

It is calculated that R_{eq}^{α} is 399.7 Ω , which is lower than the equivalent resistance of C phase faulty cable joint, as shown in formula (3). Even though the applied voltages are different, it is confirmed that there has been certain carbonation damage in the faulty cable joint at the latency stage.

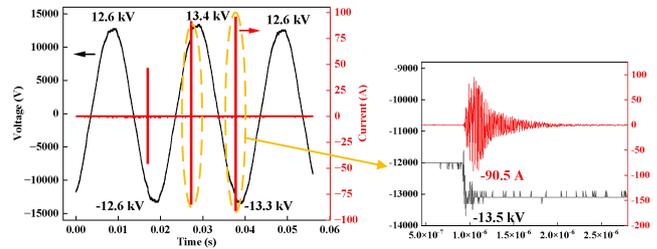
Fig.14 The measured voltage and current waves of Sample β

Fig.14 exhibits the measured voltage and current waves of Sample β under the voltage of 12.6 kV. Compared with Sample α , the amplitude and frequency of the creepage discharge is much higher. The highest amplitude of the current is up to -90.5 A. Similarly, when a large pulse current occurs, the voltage waveform at the power supply side is slightly increased. It can be calculated that:

It is calculated that R_{eq}^{β} is 129.2 Ω , which is only 32.3% of R_{eq}^{α} . It is indicated that the formation of consecutive carbonization channels at the XLPE insulation and the exacerbation of carbonization at the semiconducting layer result in the decline of equivalent resistance during creepage discharge. In turn, the aggravation of the creepage discharge promotes further damage to the XLPE insulation and the semiconducting layer.

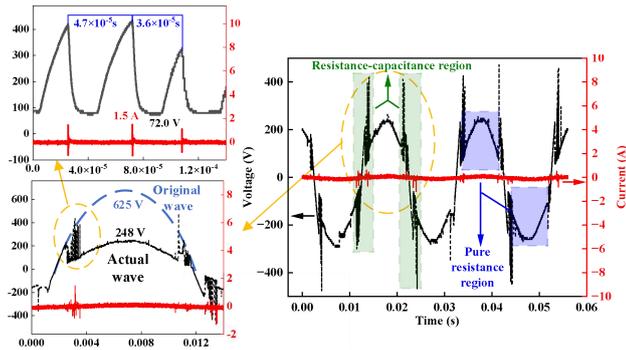
Fig.15 The measured voltage and current waves of Sample γ

Fig.15 exhibits the measured voltage and current waves of Sample γ . When the original voltage is applied to 625 V, the actual voltage waveform is seriously distorted. This can be divided into two regions for analysis. Firstly, when the AC voltage rises from 0 to about 200 V, Sample γ is in the resistance-capacitance region. This means Sample γ still has the insulation characteristics. Secondly, when the voltage exceeds 200 V, there are obvious pulse currents, the maximum of which is 1.5 A. Subsequently, the generation of the currents pulls down the original voltage wave, and the sawtooth voltage waves appear. Thirdly, when the voltage rises to about 400 V, the capacitance characteristic disappears. At this time, Sample γ is in the pure resistance region and the voltage drops to 248 V. Finally, when the voltage drops to about 400 V, Sample γ re-enters the resistance-capacitance region. This phenomenon is ascribed to the capacity limitation of the high-voltage transformer. It can be calculated that:

It is obtained that R_{eq}^{γ} is 28.0 Ω , which is only 7.0% of R_{eq}^{α} . It is confirmed that the formation of a fully carbonized channel leads to the loss of insulation characteristics. In the actual transmission line with a large transmission capacity, huge discharge energy will be released in this insulation state, leading to a large system voltage fluctuation and a series of severe chain reactions.

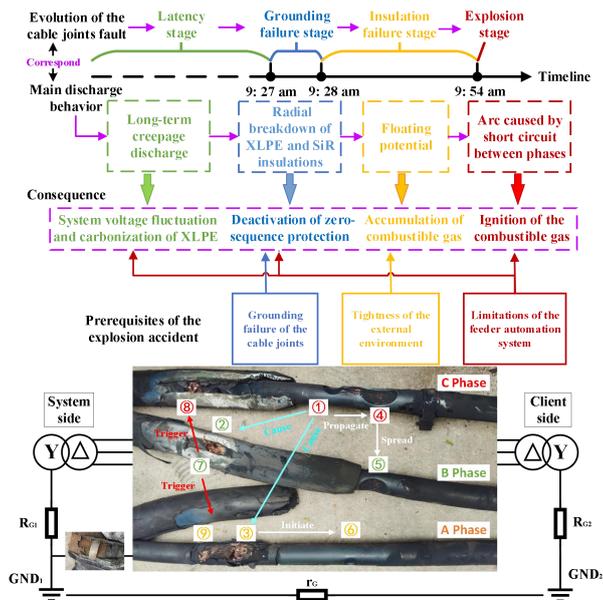
Fig.16 The timeline of the evolution of the cable joint fault

Based on the analysis of the previous four chapters, the evolution of the cable joint fault is reorganized and divided into four stages, including latency stage, grounding failure stage, insulation failure stage, and explosion stage. The timeline of the evolution of the cable joint fault is shown in Fig.16.

Combined Fig.16 with the fault recording data and experimental results, it is acknowledged that there is a long-term creepage discharge at the XLPE-SiR insulation interface of C phase cable joint. This process is defined as the latency stage of cable joint fault. This discharge behavior is responsible for the system voltage fluctuation and the subsequent radial insulation breakdown of the cable joints.

Firstly, the long-term creepage discharge is ascribed to the carbonization of the XLPE insulation. Further, the breakdown point at position ① is generated due to obvious electric field distortion. Secondly, the creepage discharge of C phase cable joint results in the elevation of the voltage of B and A phases line, inducing the breakdown points at positions ② and ③.

During the period from 9:28 am to 9:54 am, the floating potential of the cable joints continuously ablates the insulations. This is a process of accumulation stage of combustible gas as well. In Fig.16, for C phase cable joint, the floating potential at position ① intensifies the axial creepage discharge and further extends to position ④ where it is the interface between the outer semiconducting layer and copper tape shield. Pyrolysis of the insulations caused by the creepage discharge produces a certain amount of combustible gas.

At 9:54 am, the explosion caused by the ignition of the combustible gas occurs. Firstly, due to the insulation failure, the interphase breakdown between position ④ and position ⑤ happens. 1st trip protection is triggered by the arc between the conductors of B and C phases. A slight explosion results in the loss of 1/2 of the whole two-phase copper conductor. In this process, the destruction of the protection shell is exacerbated. Meanwhile, a large amount of combustible gas diffuses to the enclosed cable trench, which is in full contact with the external oxygen.

At the moment of the 1st reclosing operation, the impact of the switching surge is injected into the three-phase cable joints. The exposed conductor of position ⑦ discharges to position ⑧ and position ⑨. The stable arc generated by three-phase interphase breakdown ignites the combustible gas, leading to the explosion accident.

Limitations of the feeder automation system in the distribution network, grounding failure of the cable joints, and tightness of the external environment are the prerequisites for this explosion accident. In the actual operation and maintenance of the power distribution system, one of the prerequisites can be eliminated to prevent this accident. On the premise of not changing the existing distribution network operation mode, online monitoring of the creepage discharge is an optimal measure to predict analogous accidents currently.

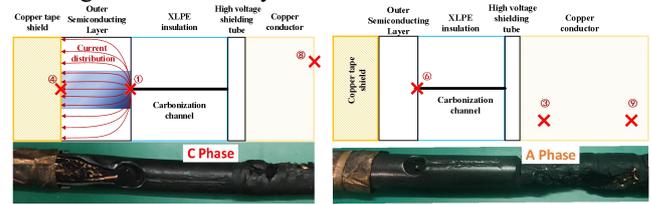
Fig.17 Diagram of damage location of C and A phase cable joints

Initiation of creepage discharge: From Section 2, it is discovered that there is a protrusion defect at the XLPE-outer semiconducting layer interface caused by inappropriate installation. At this position, the electric field is distorted distinctly [17, 18], and the insulation is degraded gradually. Faint partial discharge is easy to be activated and promotes the accumulation of space charges [19, 20]. After the space charges accumulate to a certain extent, intense partial discharge and surface flashover occur under the effect of humidity or other factors. A discontinuous carbonization channel begins to be generated above the XLPE insulation.

SiR insulation interface, a consecutive carbonization channel is gradually generated as shown in Fig. 17. The more exacerbated carbonization of the channel is, the more charge carriers are allowed to transport, which in turn aggravates the carbonization of the channel. Thus, the intensity of the creepage discharge becomes increasingly strong and results in the radial insulation breakdown at position ① and position ⑥. The details will be discussed in Section 6.3.

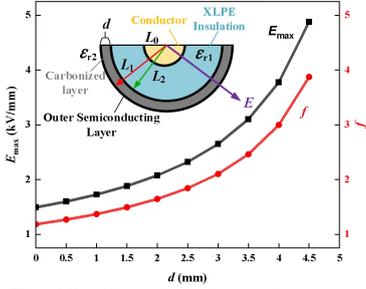
Fig.19 Calculated model and the result of the radial breakdown process of XLPE insulation

calculated that the correlation among carbonation depth d (L_2-L_1), E_{max} , and f , as shown in Fig.19.

In Fig.19, it is observed that E_{max} of the XLPE insulation increases abruptly with the deepening of d . When d reaches 3 mm, $f > 2$ and it is considered as the non-uniform electric field. During this carbonized process, E_{max} becomes increasingly intensified. When carbonization reaches a certain degree, radial breakdown of XLPE insulation occurs at position ⑤.
