Evolution of Grounding Failure-Insulation Failure of 10 kV Cable Joints: Prerequisites of an Explosion in Enclosed Cable Trench

Yifeng Zhao¹, Gang Liu¹, Yaodong Guo¹, Chenglong Huang¹, Zhaoming He¹, and Ran Hu¹

¹South China University of Technology

March 31, 2023

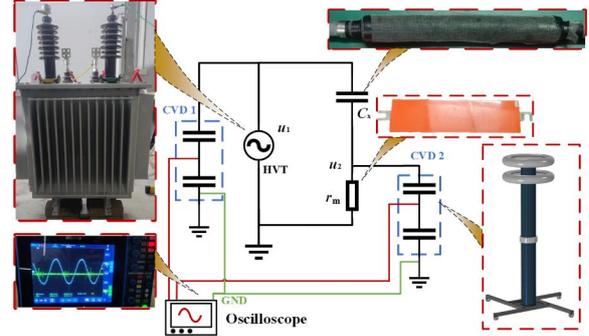
Fig.12 The schematic diagram of the experiment

The creepage discharge voltage and current waves of the samples were measured under the high voltage condition. The purpose of the test is to explore the changes in the creepage discharge behavior of the samples with the evolution of carbonation damage. The site diagram and schematic diagram of the test are shown in Fig.12. Where HVT is the high-voltage transformer with a capacity of 110 kVA (22 kV, 5 A); r_m is the non-inductive resistance (20 Ω), which is applied to calculate the loop current; C_x is the selected sample where the conductor is connected to the high voltage, and the outer semi-conducting layer is wrapped with copper mesh and connected to r_m ; CVD1 and CVD2 are the capacitive voltage dividers, which are applied to measure the voltages of HVT (u_1) and r_m (u_2). The sampling frequency of the oscilloscope is set to 1 GS/s (the sampling time, $T_s = 1$ ns) with 100 MHz bandwidth.
